## Catch of the Month

## **Power & Utilities:** Exposing Configuration Challenges

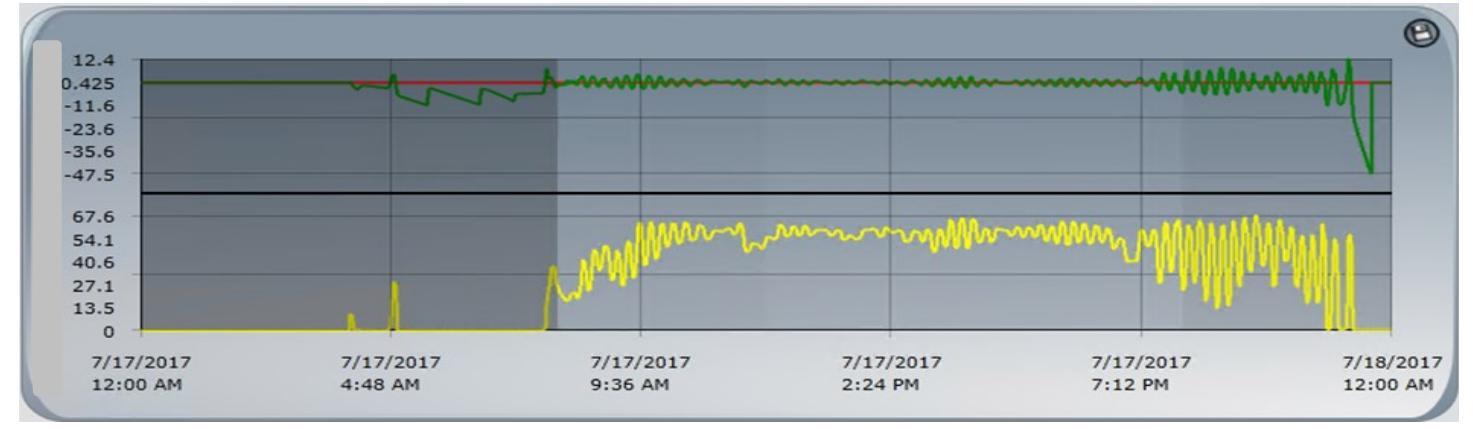
In addition to trending key performance indices (KPIs) PlantESP can trend the process data from a given PID control loop as another valuable reference point. Shown above is a trend of the HRSG unit's drum level controller. While the Process Variable (green line) showcases limited oscillatory behavior the Controller Output (yellow line) exhibits significant oscillations as soon as start-up procedures are initiated.

A typical power plant employs 100s of individual PID control loops to regulate steam generation. Whereas most loops are used to control simple processes involving a single element others loops are configured using more complex structures. Such a configuration had been intended for the HRSG unit in support of routine start-ups. Indeed, the three-element design allows for safer, more efficient start-up operation by combining the benefits of cascade and feedforward control. Interactions between each of the HRSG's drum level, feedwater flow, and steam flow are highly coordinated. However, with so many PIDs it's not uncommon for configuration mishaps to occur. The highly robust nature of PID control is such that performance can remain strong and mishaps can be easily overlooked.

In addition to mechanical and controller tuning issues PlantESP's KPIs uncover problems associated with ineffective process architecture. Shortly after its deployment at the power plant the software flagged loops associated with the HRSG unit for exhibiting oscillatory behavior during start-up. The oscillations resulted in similarly high Output Travel measurements. The Oscillation Likelihood metric was found at 81% with a corresponding Output Travel value of 2.3 strokes/hour. The readings led plant staff to examine the process data which confirmed PlantESP's findings and resulted in an adjustment to the loop's configuration. With three-element control in place the KPI for Oscillation Likelihood dropped by 79% and Output Travel was reduced to less than 0.3 strokes/hour.
