Catch of the Month

Avoiding Issues with Actionable Reporting

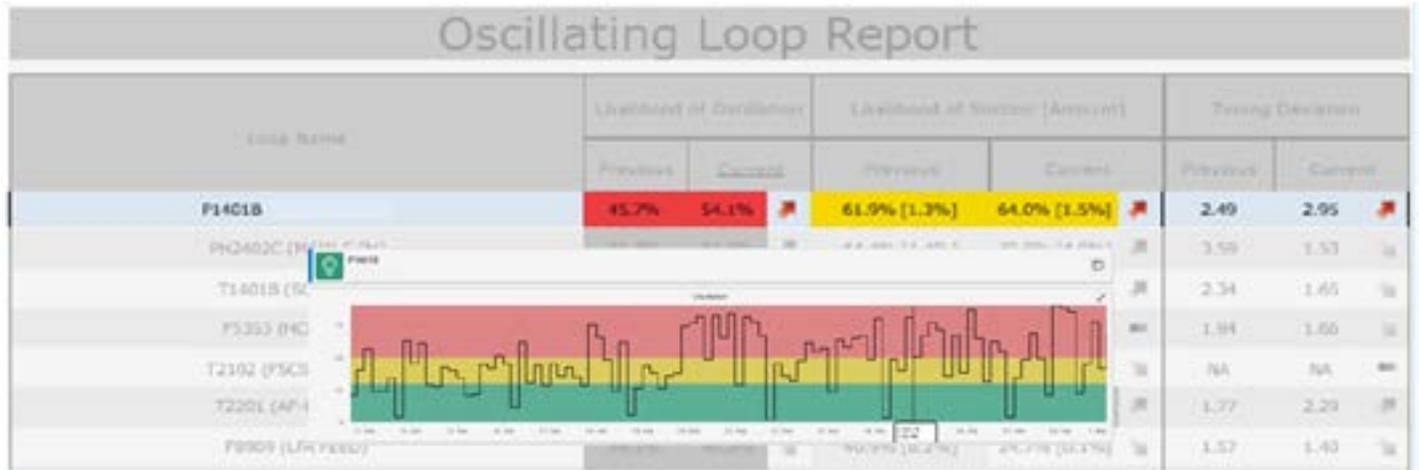
Key Performance Indices

PlantESP reports provide a regular assessment of plant-wide control and they can be used to set weekly performance tasks. Each control loop listed is hyperlinked so that essential details are no more than a click away. PlantESP utilizes stop light trends to clearly show how a given PID controller performs over time. Trends for each of PlantESP's core KPIs help to place complex data into a more simplified context.

PlantESP includes numerous reports that highlight changes in control loop performance. The initial Oscillating Loop Report captured the attention of engineers onsite. It listed the seed crystallizer pressure loop among those with a high and steadily increasing probability of oscillatory behavior. Clicking thru to the control loop's details, PlantESP showcased a trend that exhibited the steady increase in Oscillation and it recommended an assessment of the valve. Other KPIs confirmed the presence of 1.5% Stiction in the valve.
